Flood Control Project Maintenance
2019 Structure Summary Report
Overall Unit and Item Ratings

Plumas County

North Fork Feather River Diversion Channel Drop Structure No. 1

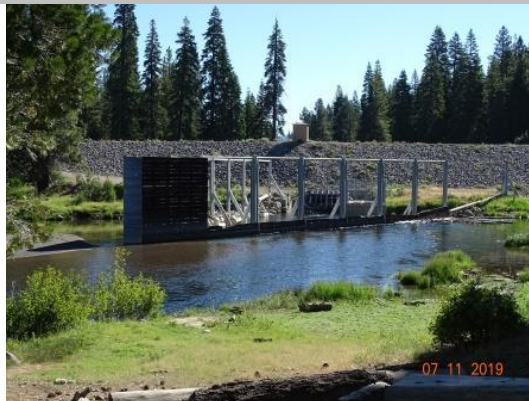
Photo 1 of 3 : ST_2019_NA0015_37_23_20190718_00021.jpg

View of the dam and structure from the inlet, 2019.

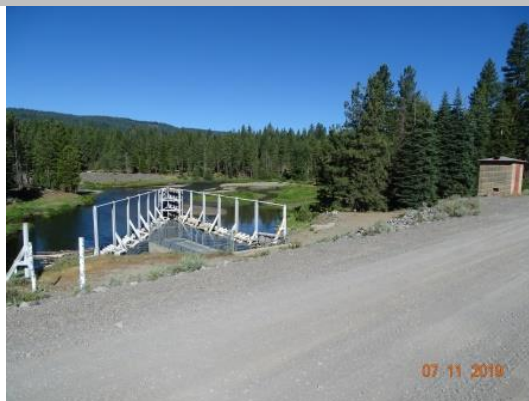
Photo 2 of 3 : ST_2019_NA0015_37_23_20190718_00019.jpg

View of the dam intake and debris diversion structure, 2019.

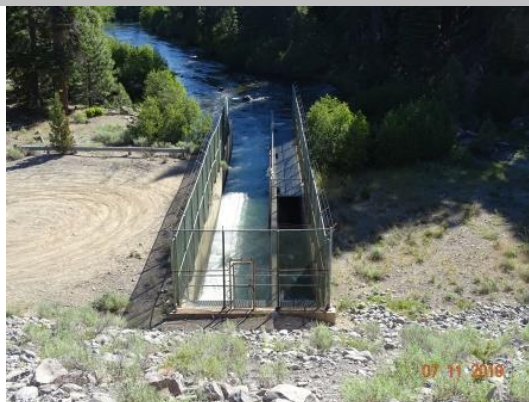
Photo 3 of 3 : ST_2019_NA0015_37_23_20190718_00018.jpg

View of the outfall structure from the top of the dam, 2019.

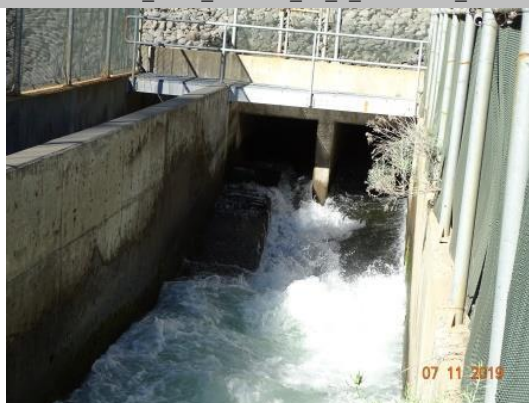
Photo 1 of 1 : ST_2019_NA0015_37_6_20190718_00025.jpg

| Inspector Comments: The inlets and outlets appear to be in good condition. Make sure trash rack is clear of debris, 2019. | | | | | |

View of the outlet box culverts, 2019.

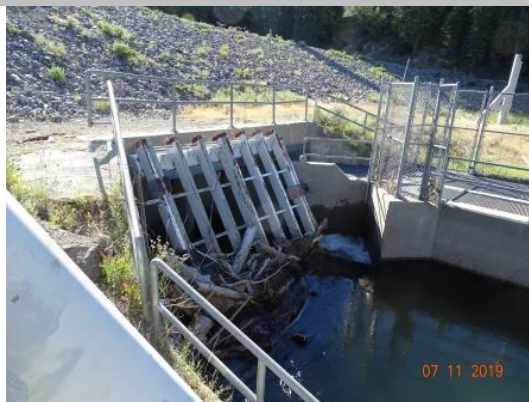
Photo 1 of 1 : ST_2019_NA0015_37_9_20190718_00026.jpg

| Inspector Comments: Trash rack is well maintained but debris needs to be removed, 2019. | | | | | |

View of the trash rack, 2019.

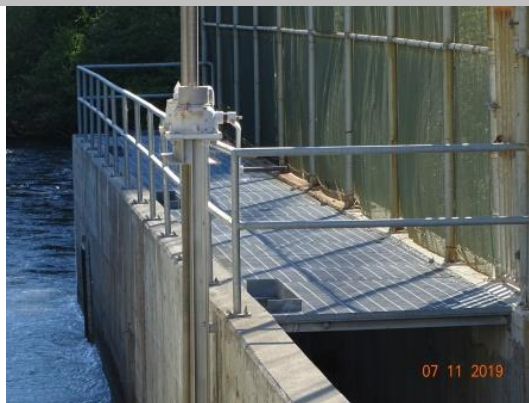
Photo 1 of 2 : ST_2019_NA0015_37_13_20190718_00030.jpg

| Inspector Comments: Manual gate operator appears to be working as intended, fittings have been greased and the LMA was there to show the operation of them last year in 2018. | | | | | |

View of the manual screw gates for the fish ladder slide gate on the outfall structure, 2019.

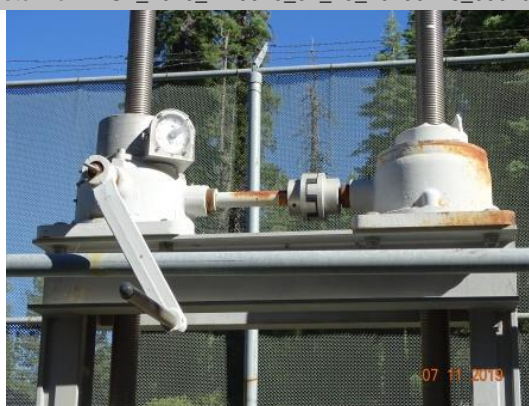
Photo 2 of 2 : ST_2019_NA0015_37_13_20190718_00029.jpg

Closer view of the manual screw gates for the fish ladder slide gate on the outfall structure, 2019.

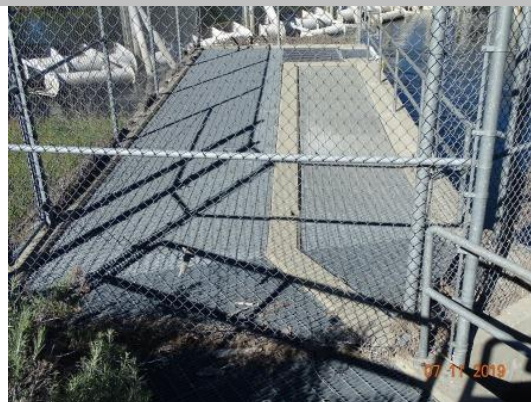
Photo 1 of 3 : ST_2019_NA0015_37_17_20190718_00039.jpg

| Inspector Comments: Safety / security fence is in good condition around the inlet and fish ladder, also outfall structure and the fish ladder outfall, 2019. | | | | | |

View of the security fencing around the fish ladder, 2019.

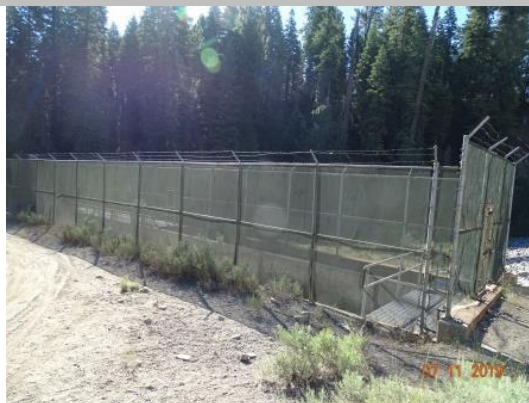
Photo 2 of 3 : ST_2019_NA0015_37_17_20190718_00040.jpg

| Inspector Comments: Safety / security fence is in good condition around the inlet and fish ladder, also outfall structure and the fish ladder outfall, 2019. | | | | | | |

View of the security fencing around the outfall, 2019.

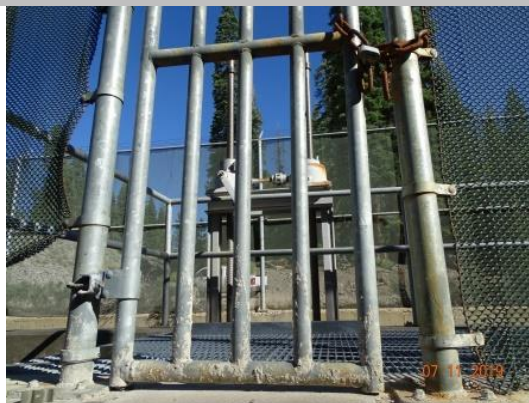
Photo 3 of 3 : ST_2019_NA0015_37_17_20190718_00041.jpg

View of the security gate into the fish ladder at the outfall, 2019.

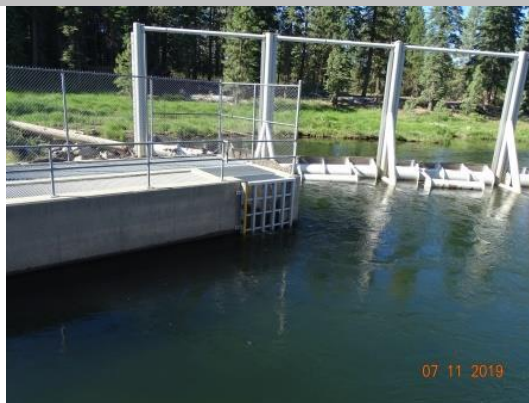
Photo 1 of 2 : ST_2019_NA0015_37_18_20190718_00037.jpg

| Inspector Comments: It appears the closure structure is in good condition. Make sure the flash board drop structures properly seal the front of the structure each year, 2019. | | | | | |

View of the inside of the debris protection closures at the structure inlet, 2019.

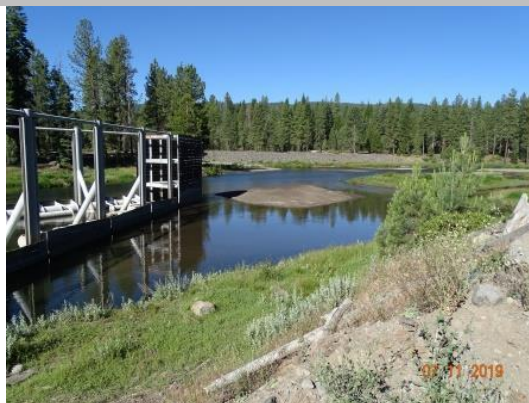
Photo 2 of 2 : ST_2019_NA0015_37_18_20190718_00038.jpg

| Inspector Comments: It appears the closure structure is in good condition. Make sure the flash board drop structures properly seal the front of the structure each year, 2019. | | | | | | |

View of the outside of the debris protection closures at the structure inlet, 2019.

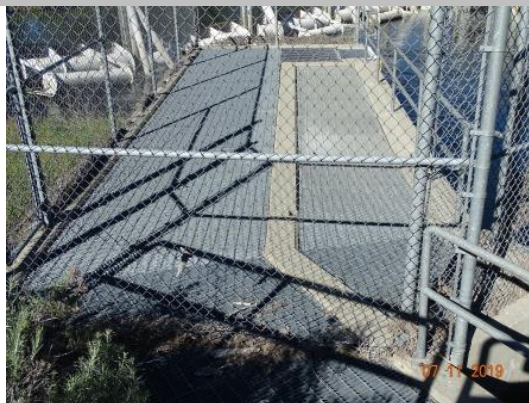
Photo 1 of 2 : ST_2019_NA0015_37_20_20190718_00035.jpg

| Inspector Comments: All the metal decks are in good condition, 2019. | | | | | |

View of the metal deck of the fish ladder inlet, 2019.

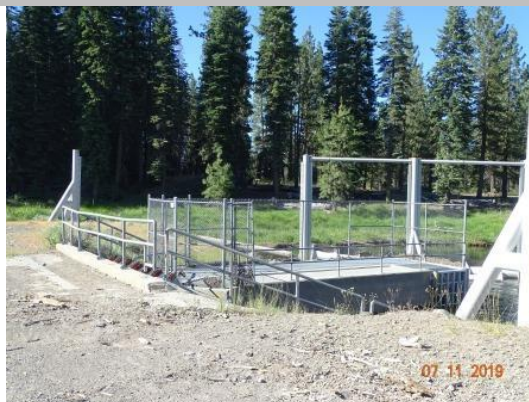
Photo 1 of 2 : ST_2019_NA0015_37_22_20190718_00034.jpg

| Inspector Comments: No safety issues identified at this location. There are hand rails around the inlet and fencing around the fish ladder for safety and fall protection, there is also security fence around the outlet of the structure, 2019. | | | | | |

View of the hand rail around the inlet and fencing around the fish ladder for safety and fall protection, 2019.
